ALABAMA HAZARDOUS WASTES MANAGEMENT AND MINIMIZATION ACT (AHWMMA)

Compliance Evaluation Inspection (CEI) Report

United Launch Alliance- Decatur Operations (ULA)

12/3/2019

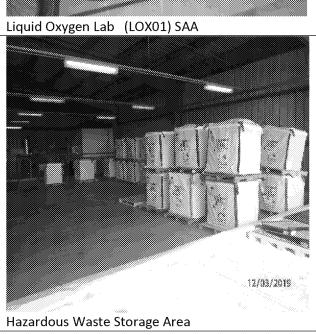
Hazardous Waste Storage Area

The hazardous waste storage area is located on the south side of the facility in a corrugated metal building. The area had the appropriate signage at every approach and was legible from 25 ft. The floor was bermed on all sides with a ramp into the area. The floor was free of any cracks or gaps. There were twenty-two cubic yard boxes for hazardous waste solids (D001, D007), three cubic yard containers of foam waste (D001, D007), three 30-gallon burlap sacks of hazardous waste (D001, D009). All of the containers were closed, labeled, dated, and in good condition. The oldest container was dated 9/14/19. The secondary containment appeared to be in good condition with no visible cracks or gaps. No areas of concern were noted in this area.
